Omron helps healthcare company minimize defects with can flange inspection system

Case study | October 2019

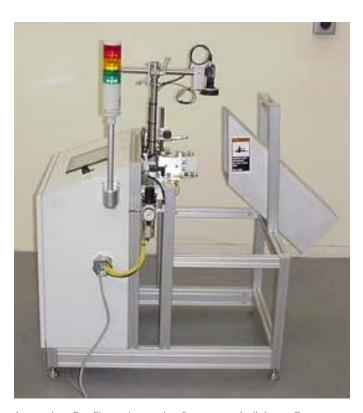
A complete Can Flange Inspection System was built by an Omron machine builder partner.

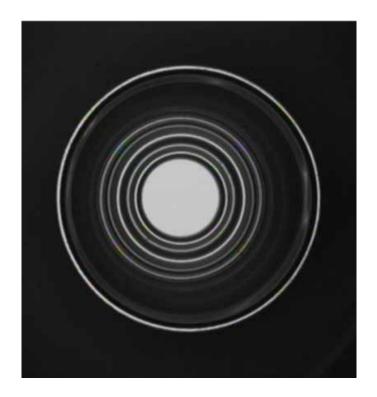
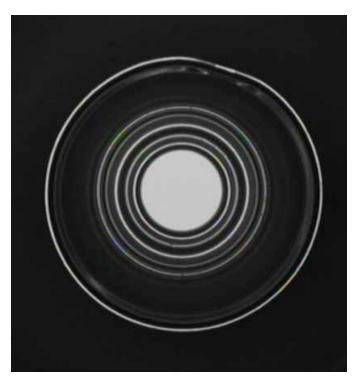
These two images of cans as seen by the camera illustrates how the lighting helps make each can's edges bright to facilitate inspection for circularity and defects. The image on the left shows a properly-formed can, while the can on the right has a defect.

The inspection camera was set up directly above the can, approximately 8 inches from its top and facing down onto the its flange area. A red low-angle ring light was set up just below the camera lens to highlight the flange, creating an excellent reflected ring on the flange of the can. The ring light causes

the light to reflect off the outer edge of the can, turning the flange area into a solid white ring and making it easy to see its circular shape. If the can flange is defective, the rim of the can will have dents showing up as distortion of the circular shape.

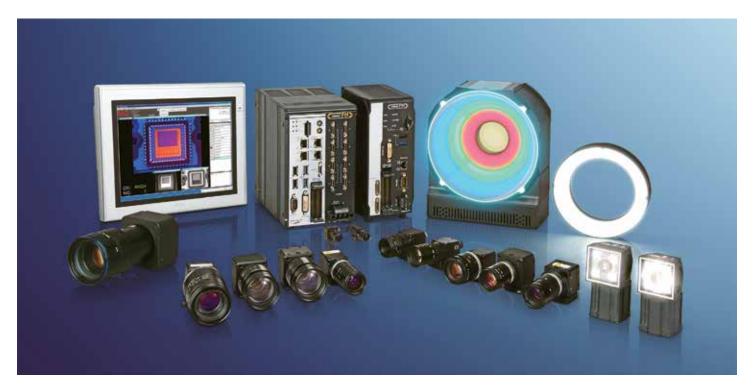
FH series vision system – High-speed, high-accuracy inspection and measurement

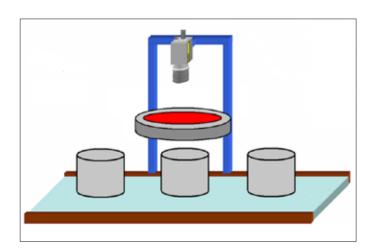
This conceptual image shows the camera and lighting placement in relation to the cans moving along the conveyor.

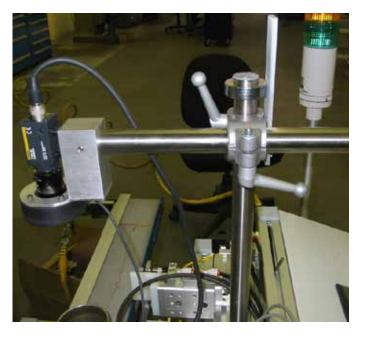
The camera and the low-angle ring light are mounted above the conveyor, with the camera's position capable of being manually adjusted in two directions.

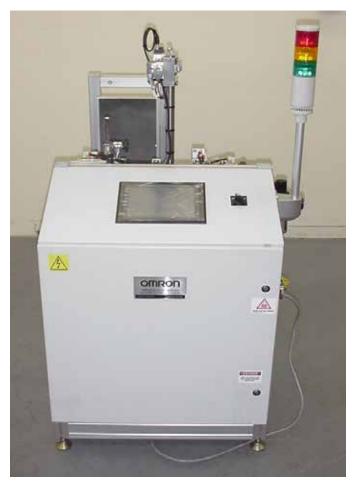
The Can Flange Inspection System's front view shows the control panel and the operator panel.

As part of the Can Flange Inspection System, Omron provided a complete control panel and camera/ light mounting assembly to fit around the existing conveyor. The control panel, HMI, cameras and light were all mounted on this assembly. The electrical control panel containing all of the electrical control components, including the main controller, vision controller, light strobe controller and power supply, was fabricated in a painted steel enclosure. An 8-inch color touch screen HMI device with a video input option for displaying the vision system camera image was mounted in a separate enclosure and located near the inspection camera.
