Omron's powerful machine vision technology helps bottled water manufacturer improve product quality and boost customer satisfaction

Case study | August 2020

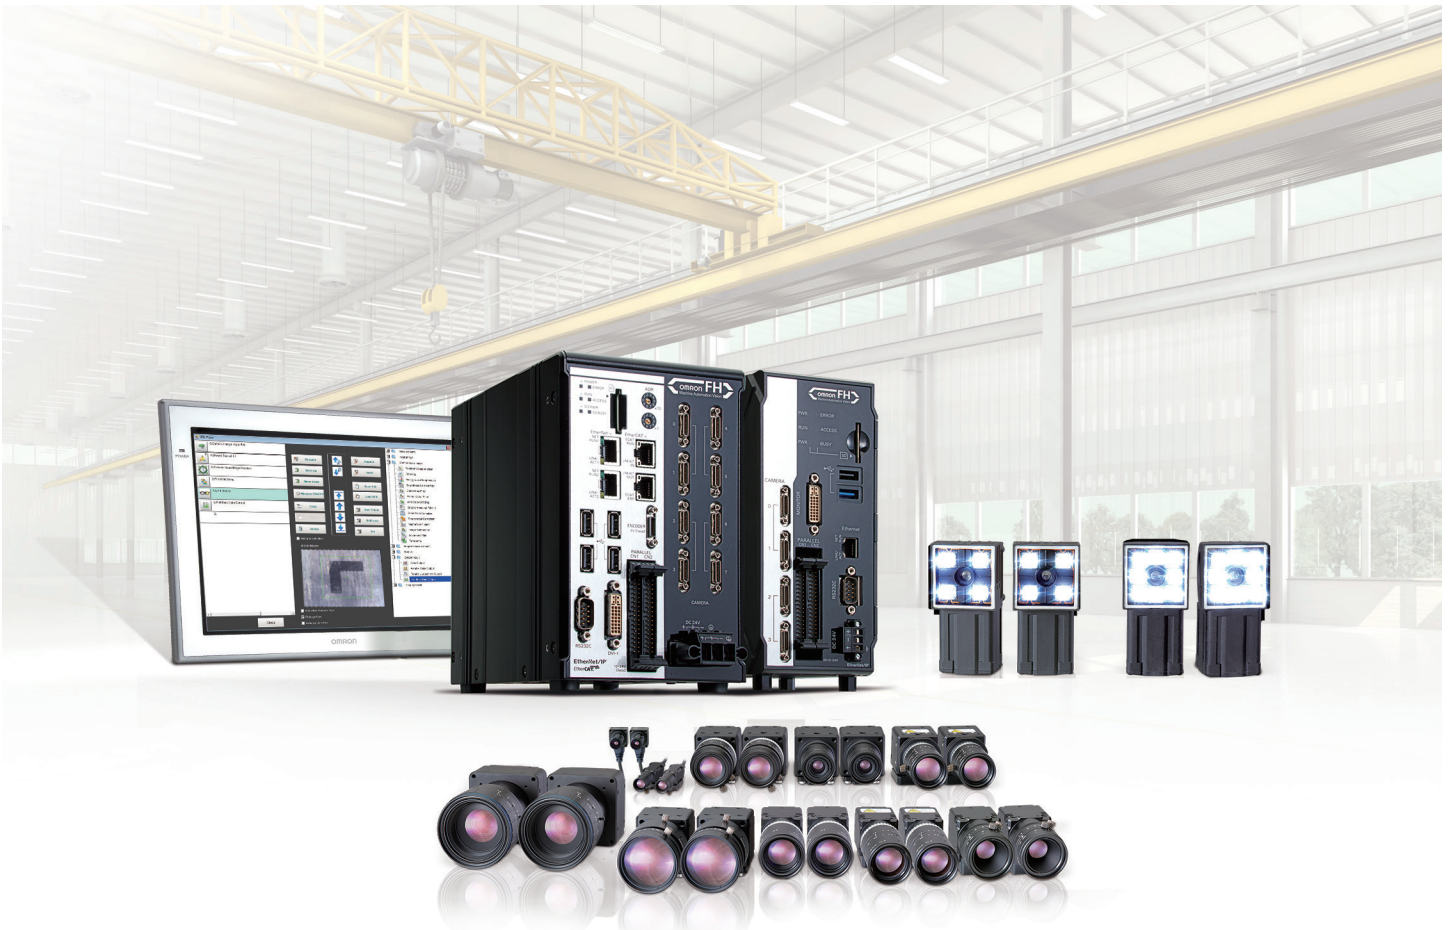
Omron’s FH Series vision system is a complete, all-in-one system that includes powerful controller options and up to 16 cameras along with menu-driven software and peripheral devices

Omron's FH Series vision system is a complete, all-in-one system that includes powerful controller options and up to 16 cameras along with menu-driven software and peripheral devices. It can be easily installed as a package on PC-based systems and has compatibility with a number of different GigE Vision cameras. The FH Series also provides real-time manufacturing process monitoring and statistical process control data.
